SUSTAINTECH 2026

Tier 3 Guideline Calculations and Risk-based Detailed Site Assessment of Salinity Yielding a Zero Remediation Outcome in Southern Saskatchewan

Presented by: K. Eric Van Gaalen, M.Sc., P.Ag. and Connor M. Frizzley, B.A.Sc., P.Ag.

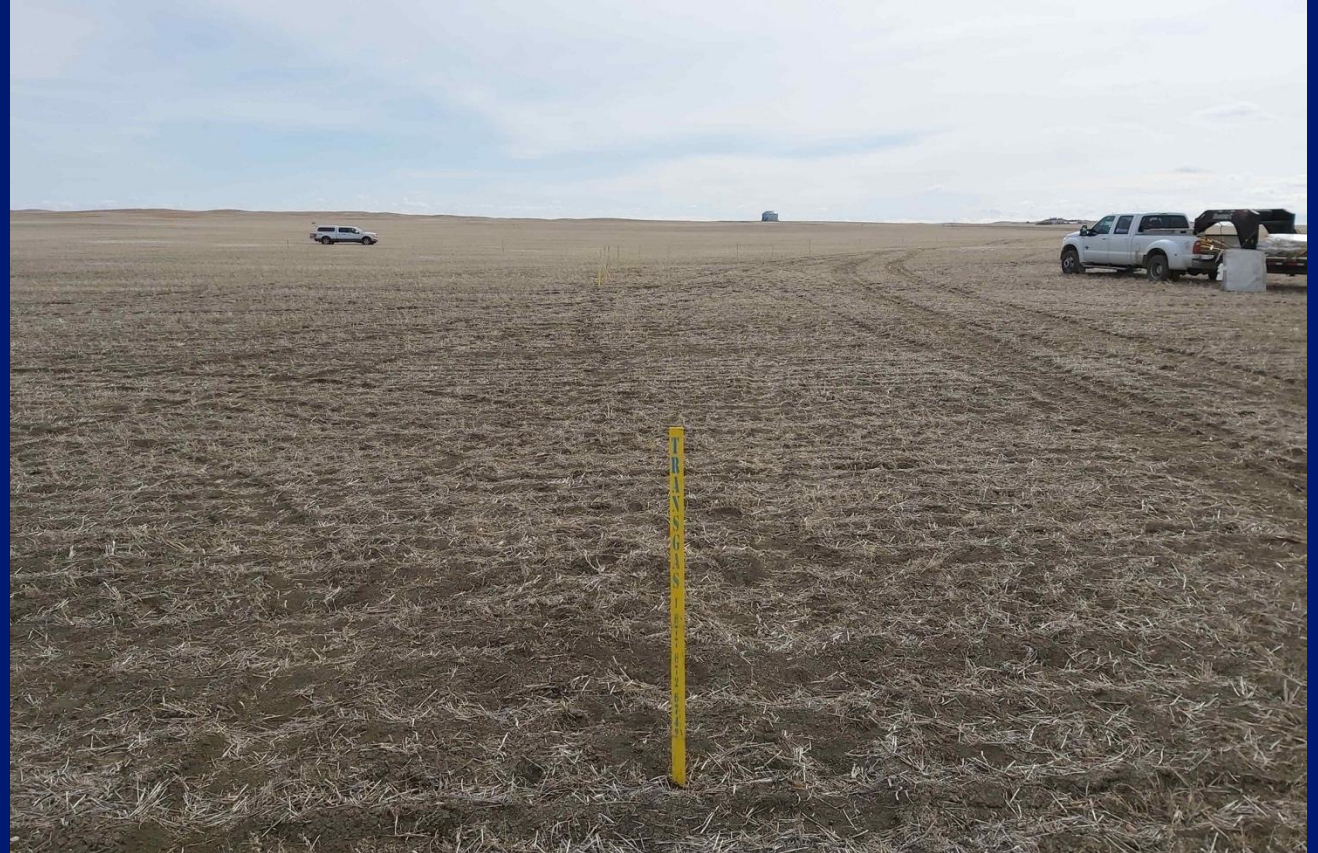
- Southwest Saskatchewan
- Drilled in 1969
- Produced 10,311,100 m³ of gas from 1972 to 1976
- Surface casing vent – brine spill in 1994
- Abandoned in 1997
- Cultivated/Agricultural land use
- Known historical infrastructure include a wellhead, flare pit, and third-party pipeline

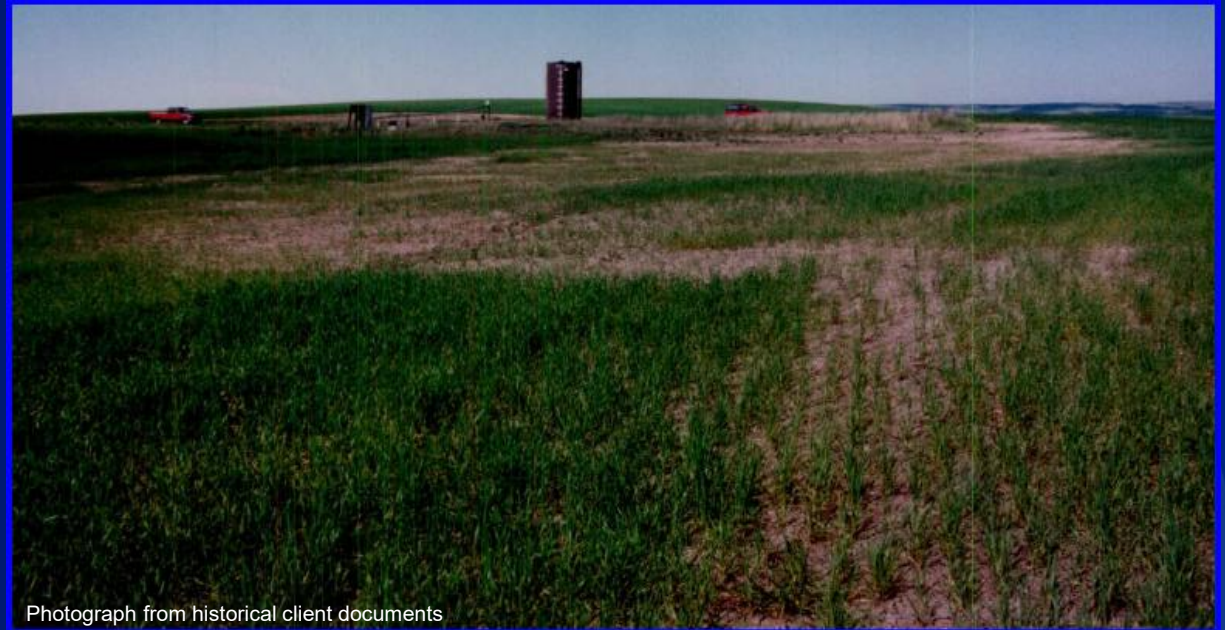
Photograph from historical client documents

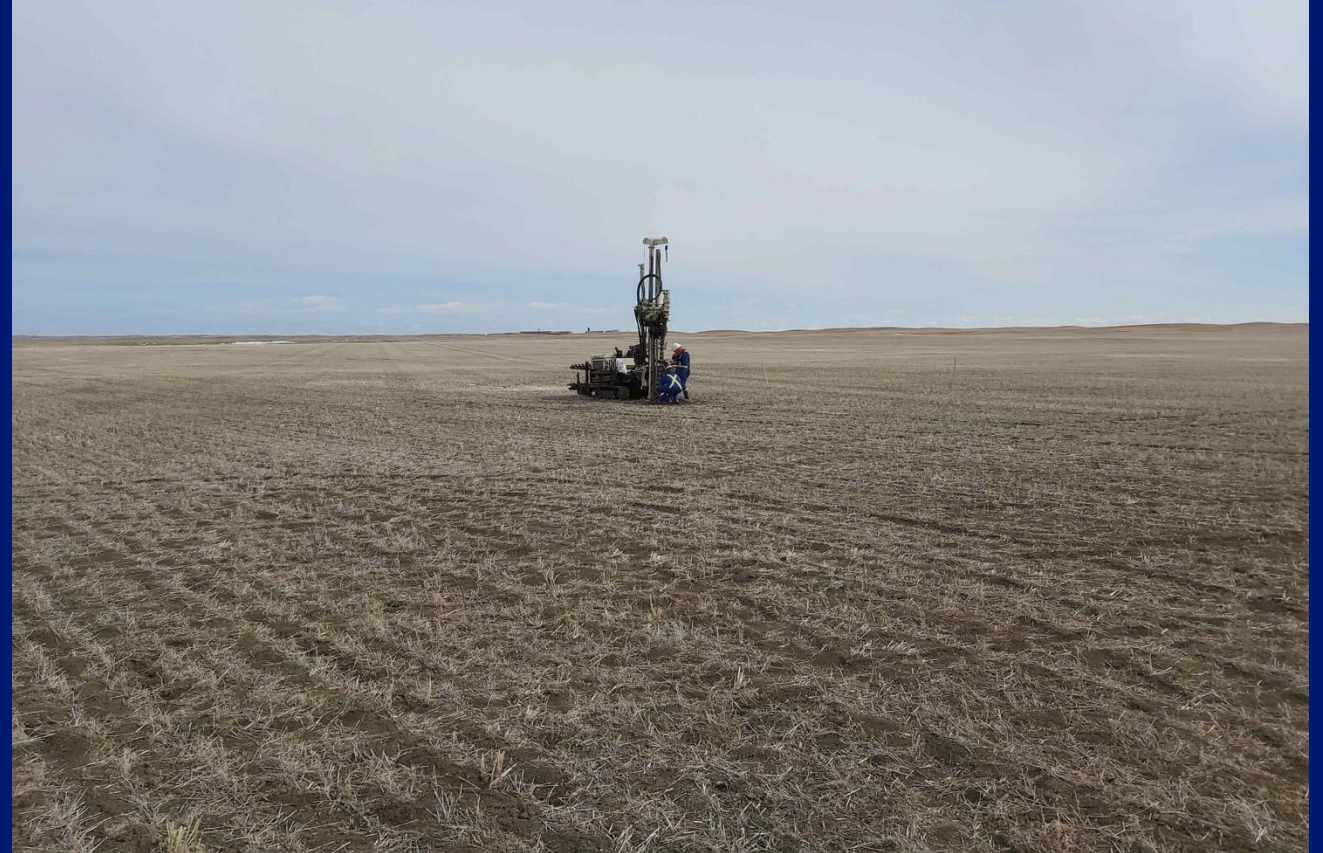
- **Options 1a, 1b, 1c:** Delineate and remediate to Tier 1 guidelines – Potentially >\$1,000,000
- **Options 2a, 2b, 2c:** Delineate / data gap fill to calculate Tier 3 guidelines
- Options analysis: guideline options/costs, remedial options, draft scenarios of Tier 3 guidelines, data gaps analysis
- Option 2 Indicated high potential for net benefit

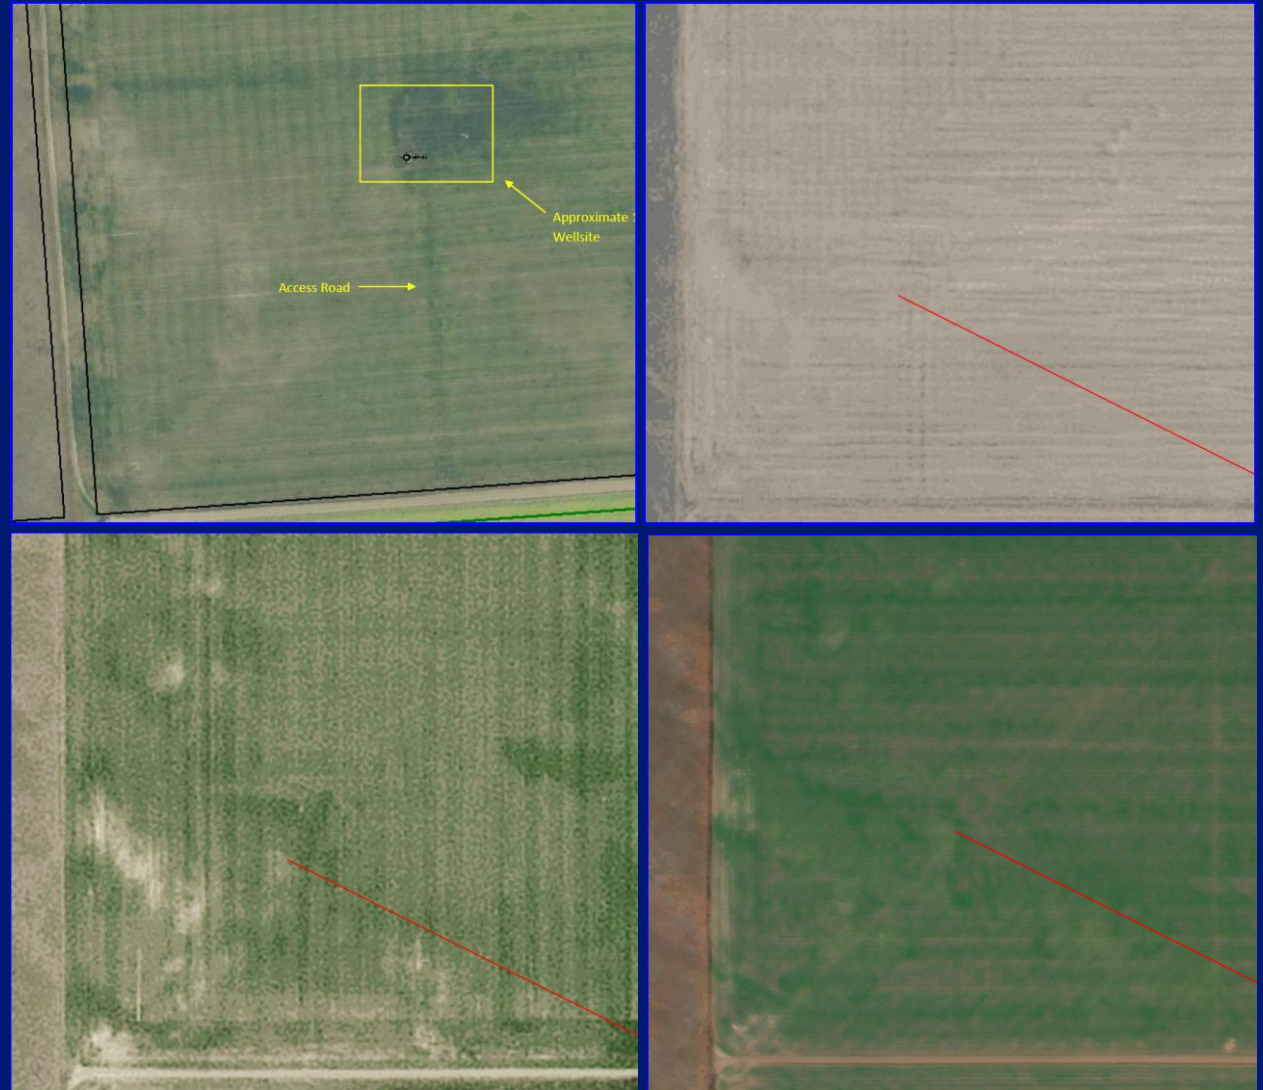
Upper left – 2011 Image Phase I ESA (Ridgeline, 2014)
Upper right – 2014 Image (AbaData – Planet)
Lower left – 2018 Image (AbaData – Planet)
Lower right – 2024 Image (AbaData – Esri)

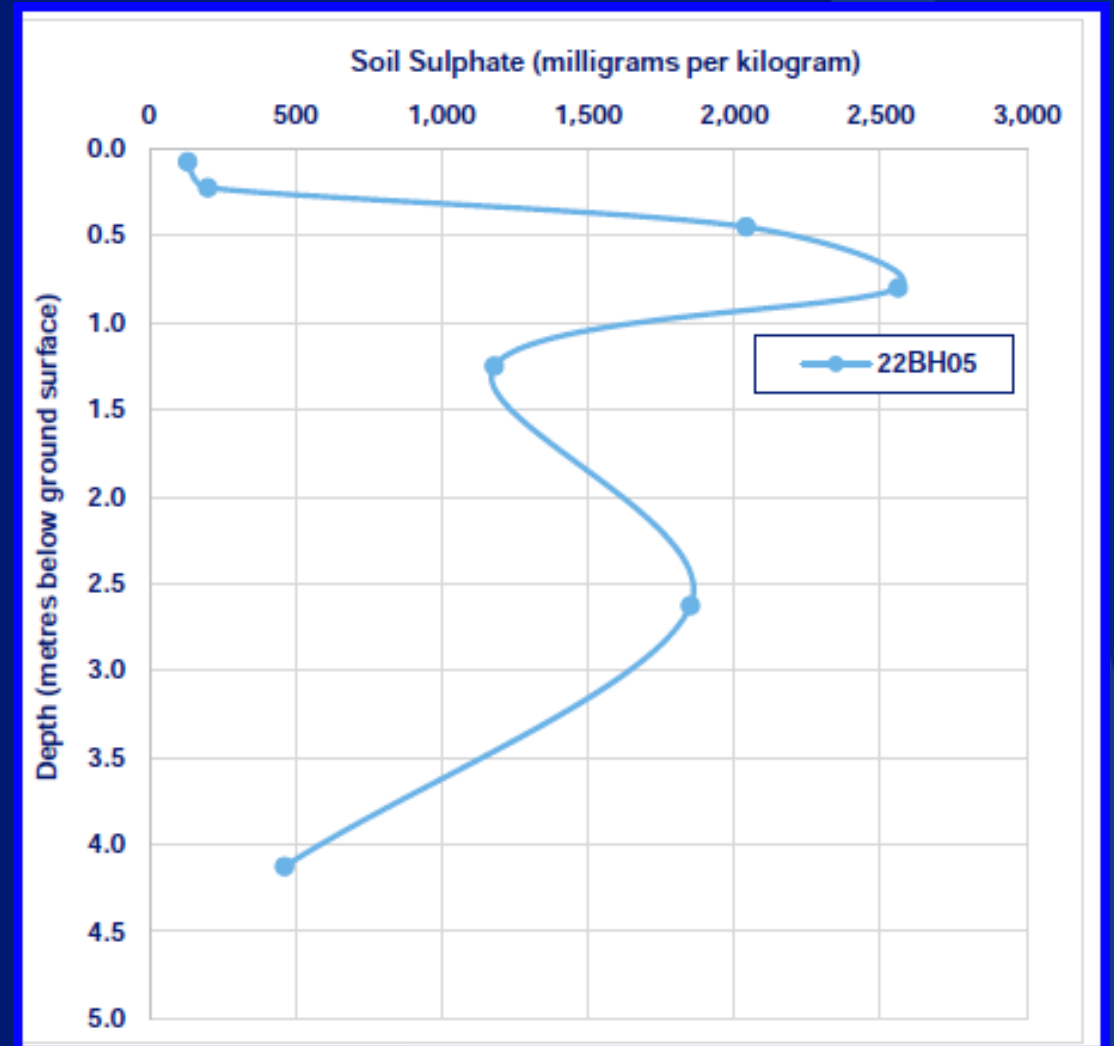
1. Salinity migrating downward over time?
Or risk of net upward movement / capillary action and accumulation at surface
2. Groundwater variables, soil texture, topography, local indicators, background sulphate profiles (example image)
3. Vegetation condition? Improving?
Declining? Constant?

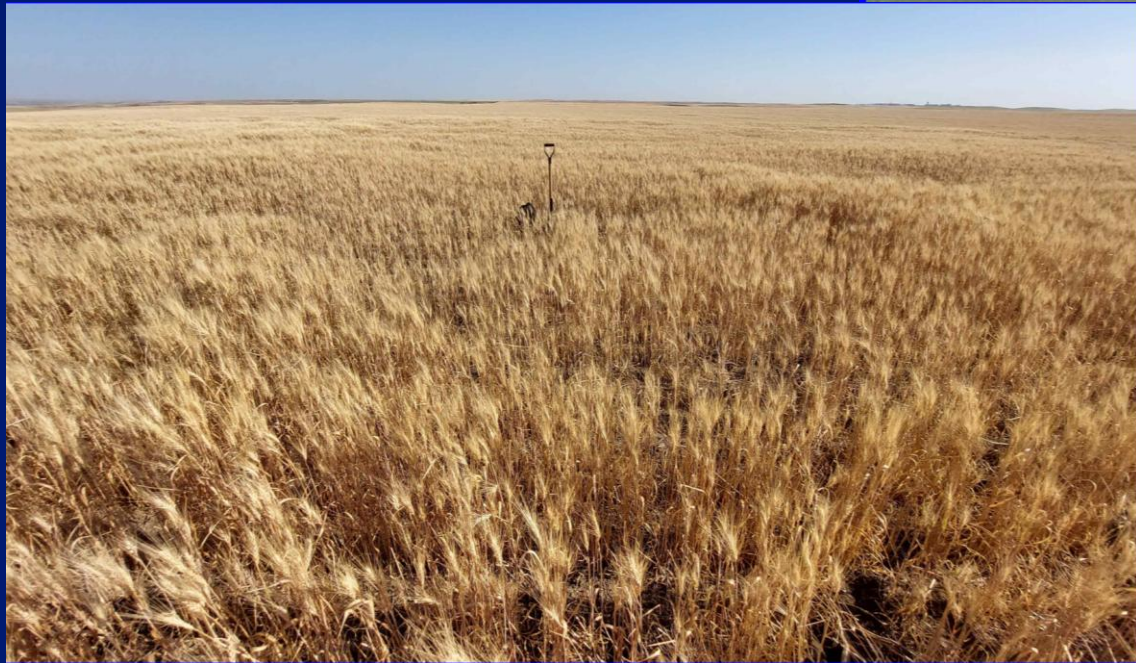
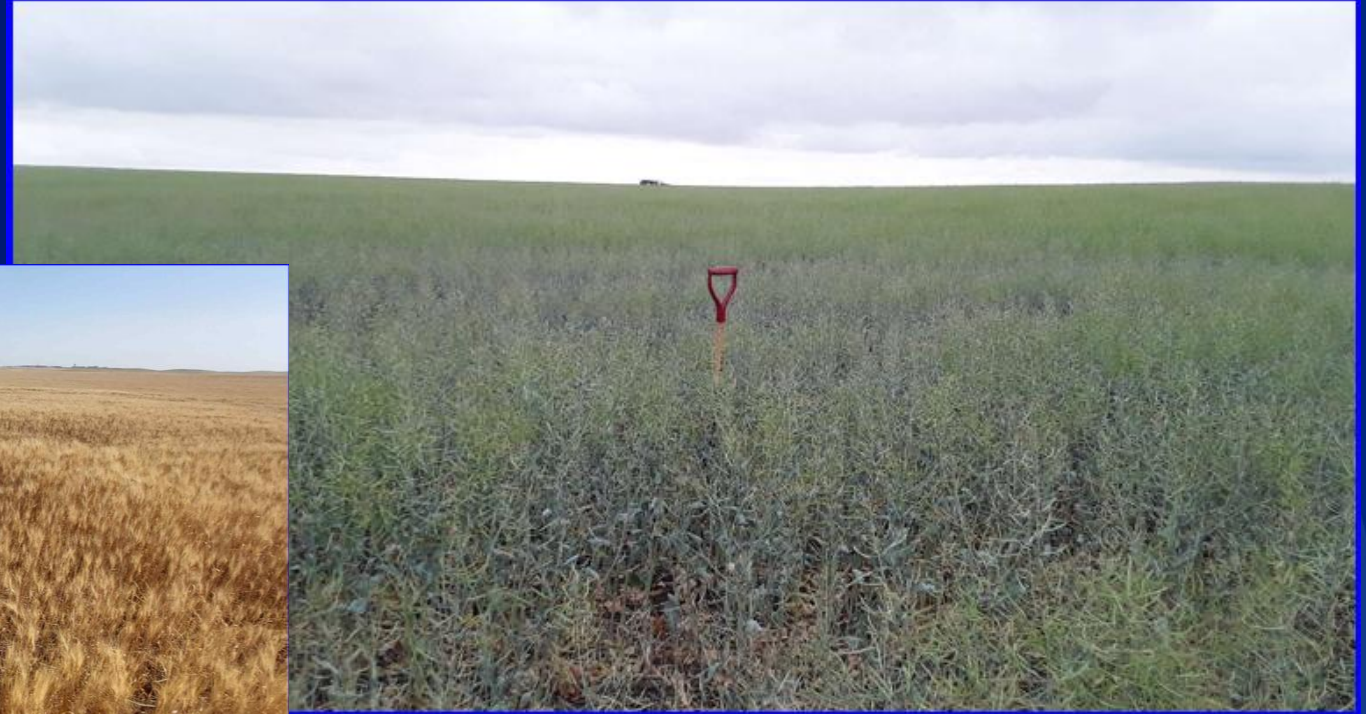
- 2023 – wheat – late prime
- 2024 – canola – early prime

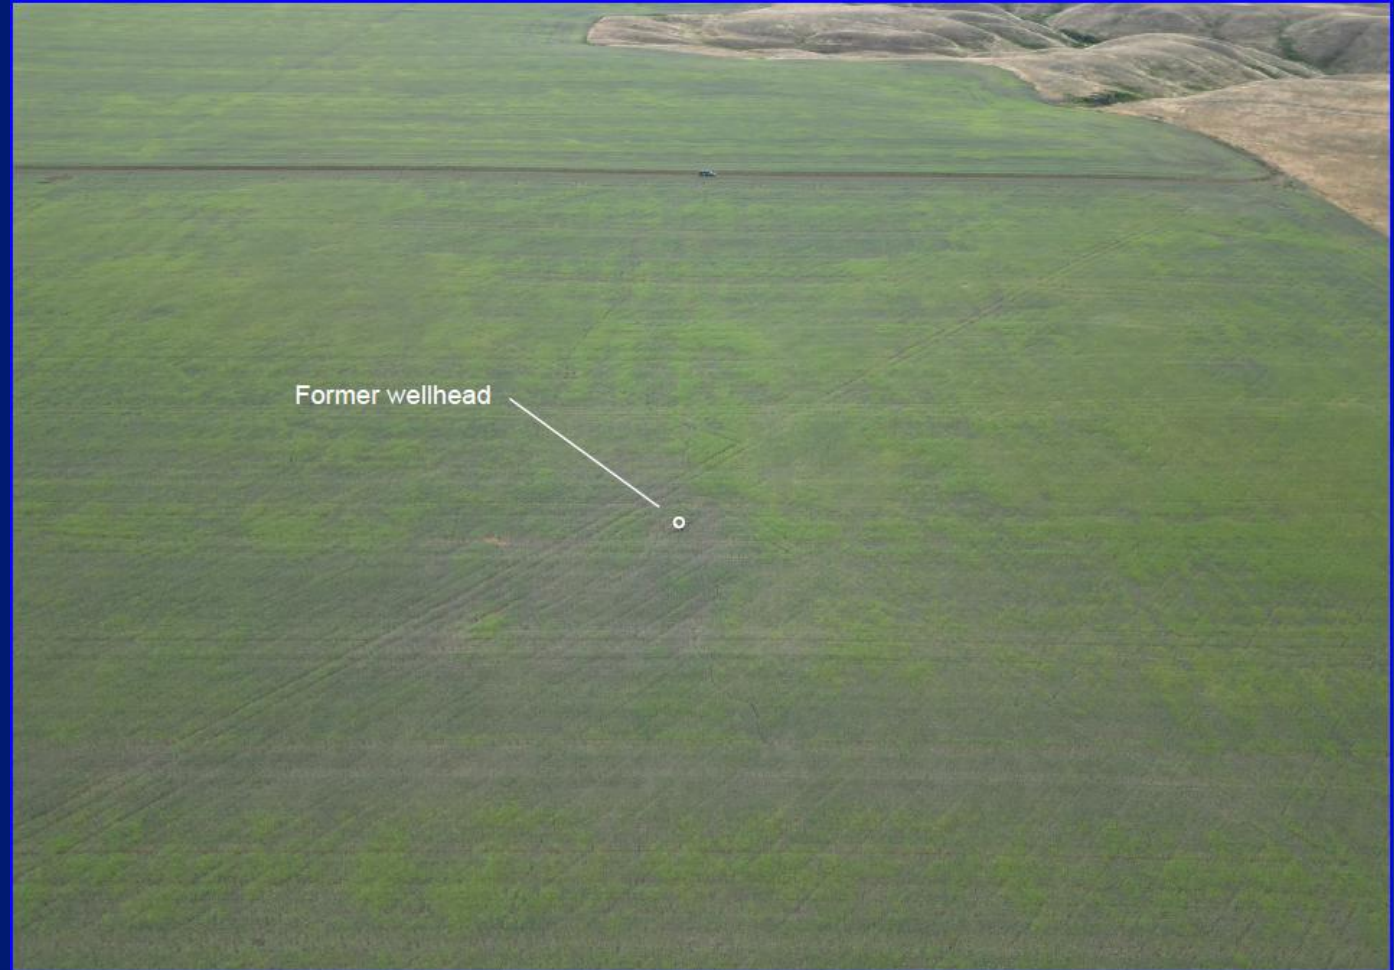
- 2024 – canola
- Early prime (still slightly green)
- Nadir – yes, added oblique imaging (e.g., looking south)
- Topographic variability, soil formation = stratify
- Background and on-site variability

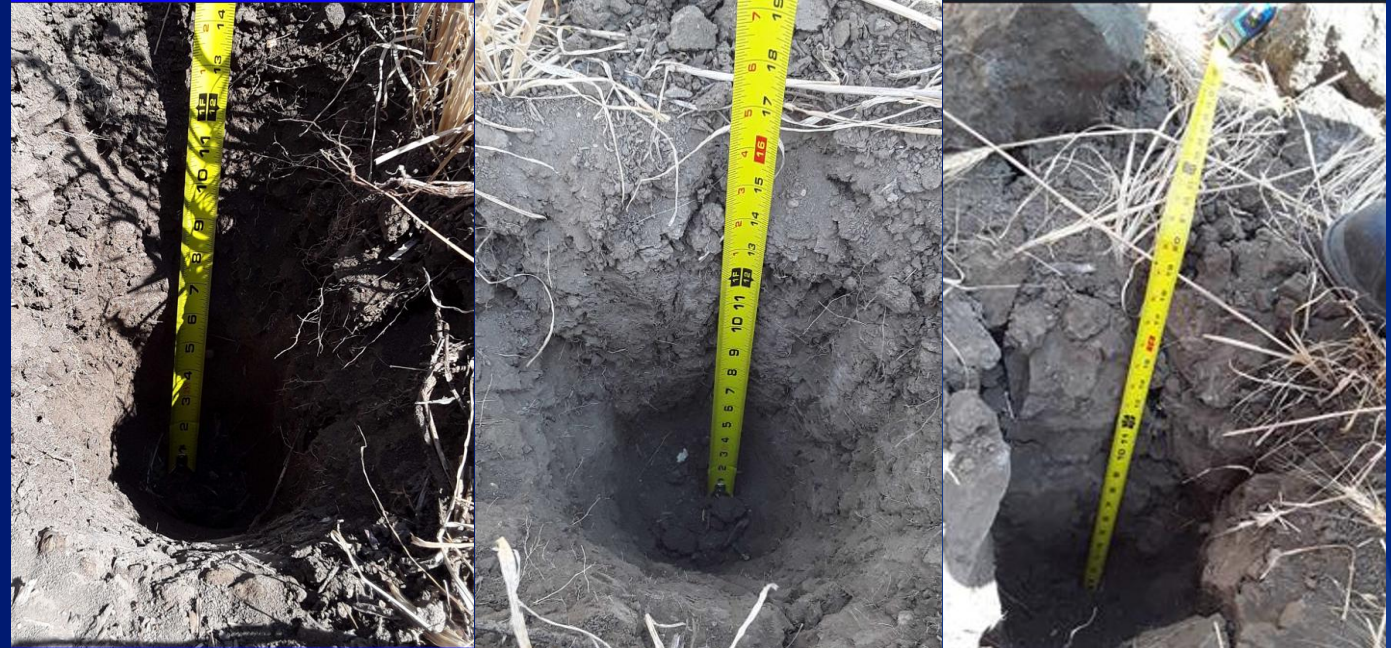
- Lab salinity, field EC and chloride
- Field colour, moisture, texture, structure, consistence (aggregate strength) inclusions, tilth, root depth / root restrictions, admixture (10% HCl), PNG018 + Canadian System of Soil Classification
- Low vegetation areas had better soil consistency ratings
- Moderate to very high clay contents (left to right) = increased vegetation performance
- Cause: clay-content, structure, consistence influencing moisture retention/release
