# ROAD SALT: RISKS, REMEDIES, AND RESPONSIBLE MANAGEMENT

Zion Yua, M.Eng., P.Eng., PMP – Associate and Environmental Manager, Prairies

## **TOWN OF SLAVE LAKE PUBLIC WORKS YARD**

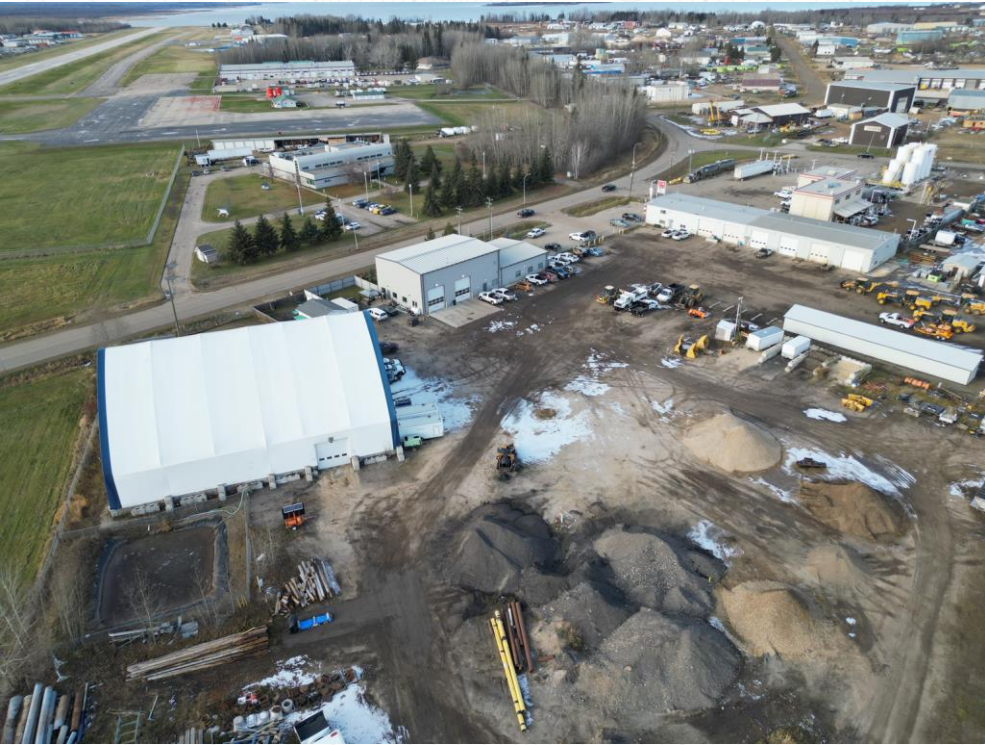
# Project Information

- Active town maintenance yard that managed winter salt and sand (pickled sand).
- Pickled sand originally stored and handled directly on the gravel yard resulted in salt infiltration into the soil and groundwater.
- Site assessments by previous consultants between 2004 and 2009.
- Alberta Environment and Protected Areas recommended additional assessments and requested a RAP and RMP for the site in 2009.

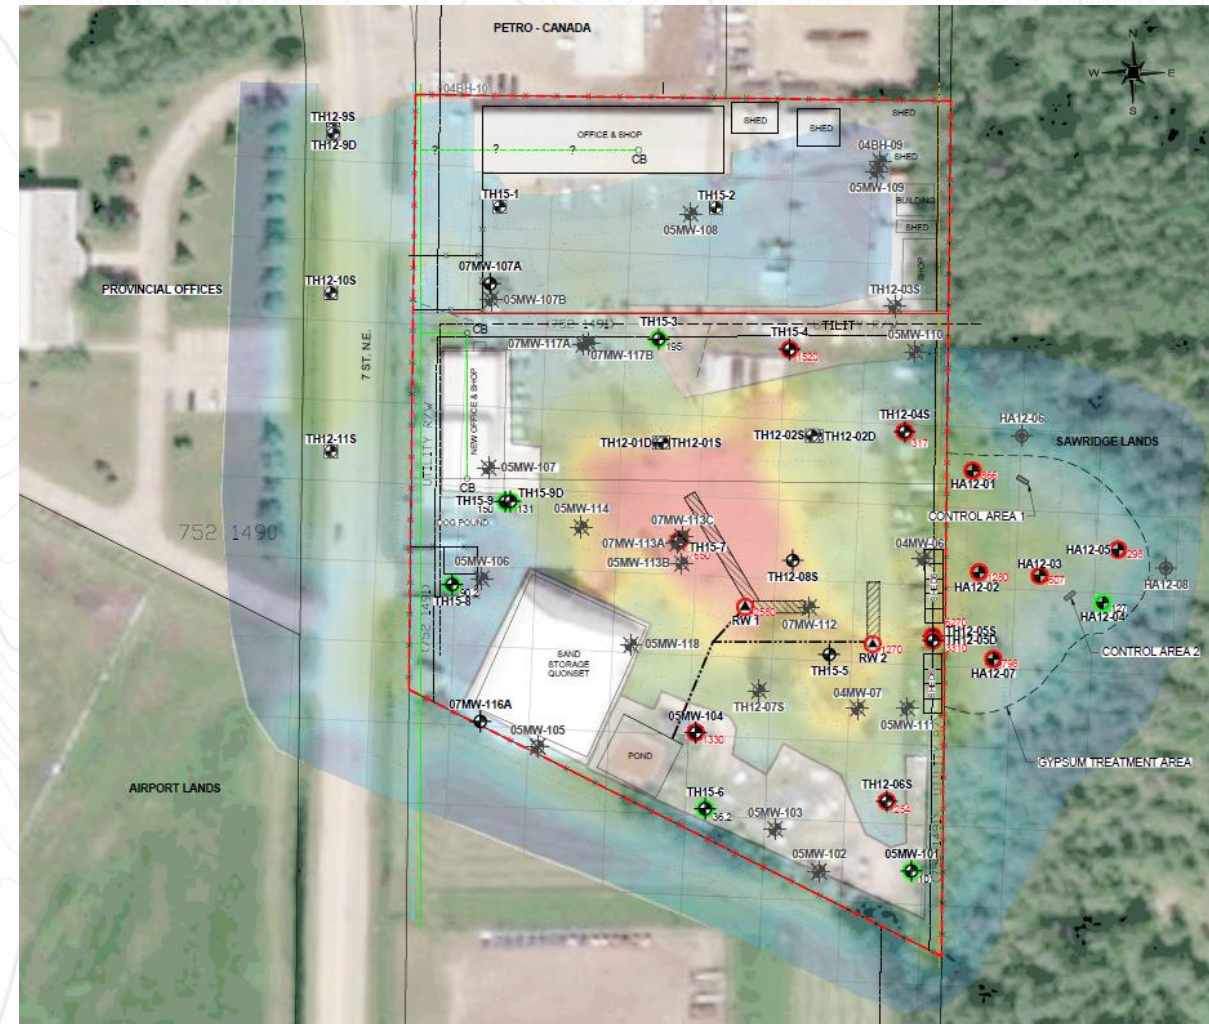
- Thurber completed Phase 3 ESAs in 2012 and 2013.
- Expanded the existing monitoring well network:
  - Road allowance area west of 7 Street
  - Sawridge First Nations land east of the site
  - Nested wells to evaluate vertical gradients
  - Sentinel wells around the site perimeter
- Delineated the salinity impacts in the soil.

- Salinity impacts identified on site in the soil and groundwater:
  - Groundwater:
    - Peak chloride ~30,000 mg/L
    - Peak sodium ~14,000 mg/L
  - Soil:
    - Peak chloride ~15,000 mg/L
    - Peak EC ~60 dS/m
- Off-site salinity impacts in the Sawridge FN land east of the site.
- Additional off-site impacts along the road allowance NW of the site.

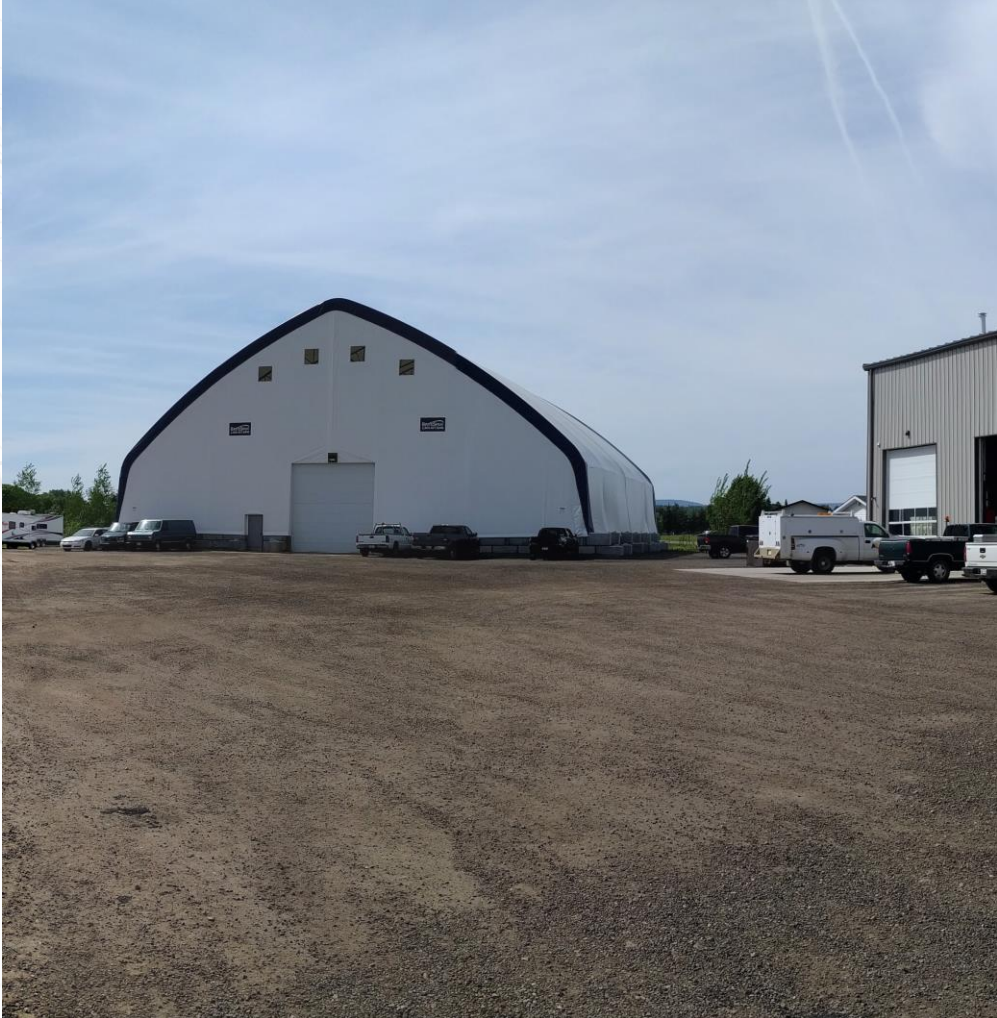
# Operational Improvements

- Operational Improvements:
  - Asphalt pad for the salt and sand stockpiles
  - Retention pond for leachate management
  - Quonset over the asphalt pad

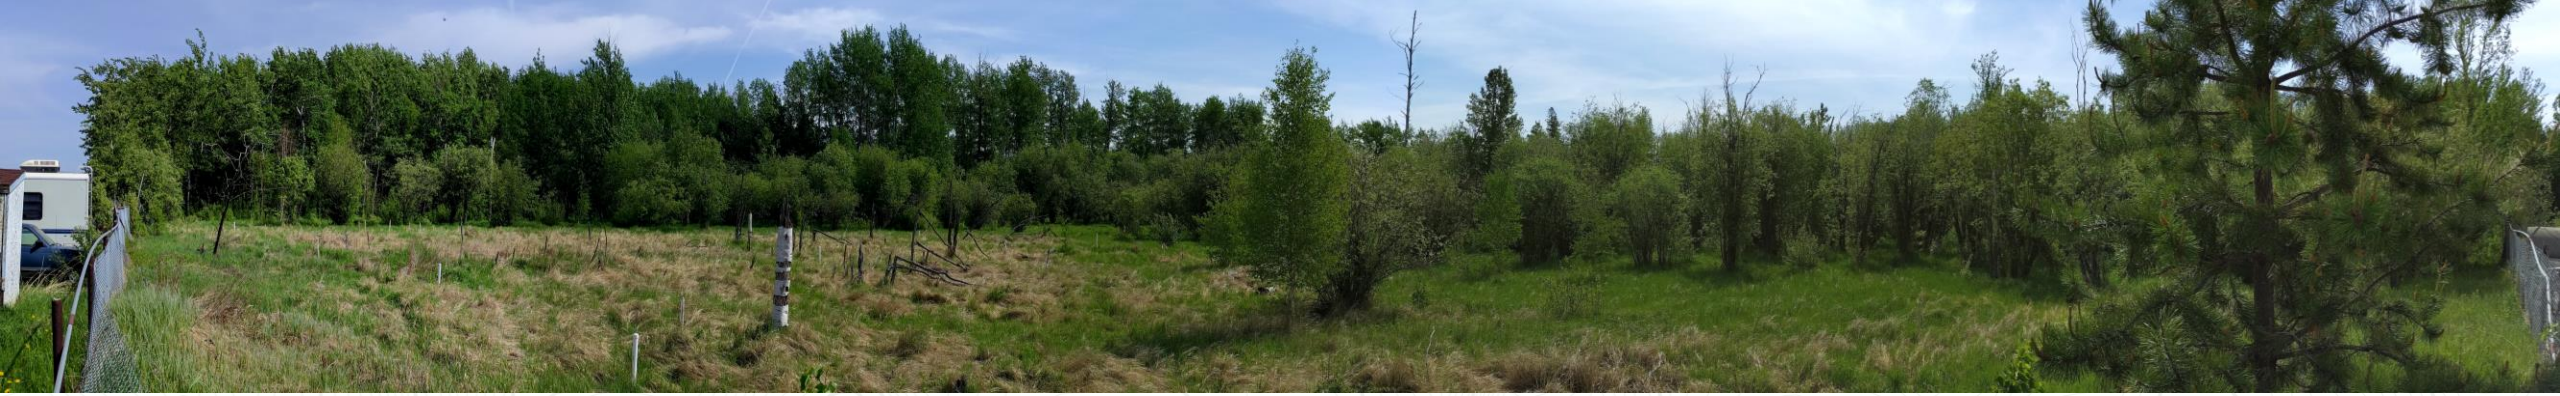
- Elevated SAR in the Sawridge FN land off-site - soil treatment with gypsum was proposed.
- Elevated sodium in soil hinders plant growth and establishment.
- Gypsum,  $\text{CaSO}_4 \cdot 2\text{H}_2\text{O}$ , is added to soil.
  - Sodium cations that were adsorbed to soil particles are replaced by calcium cations from the gypsum amendment.
  - The sodium is then mobilized and flushed through the soil.
- Gypsum amendment was conducted during the growing season annually.
- Soil monitoring to assess the soil quality during treatment.
- Managing EC levels during soil treatment.

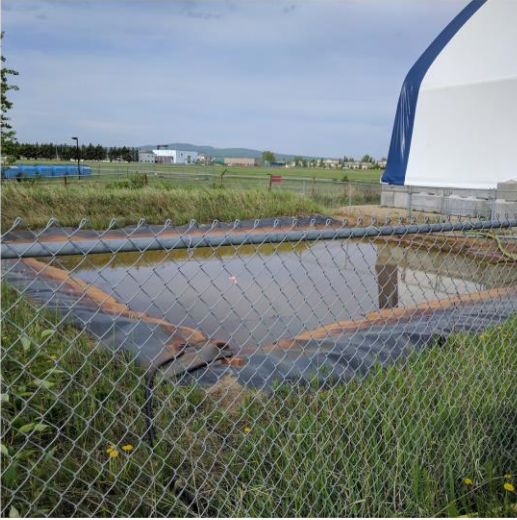
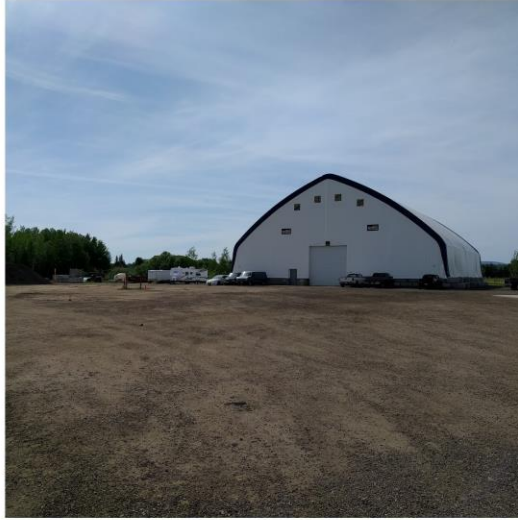
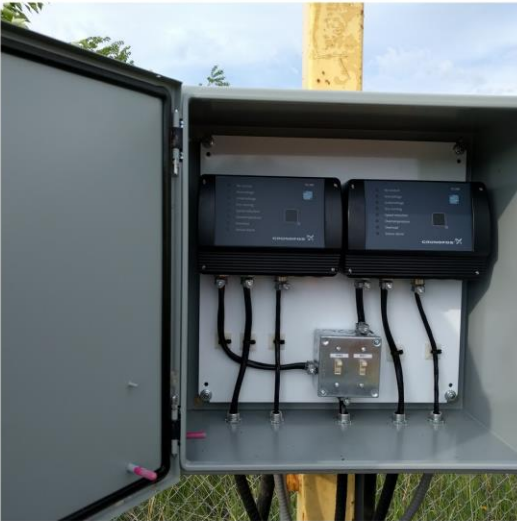
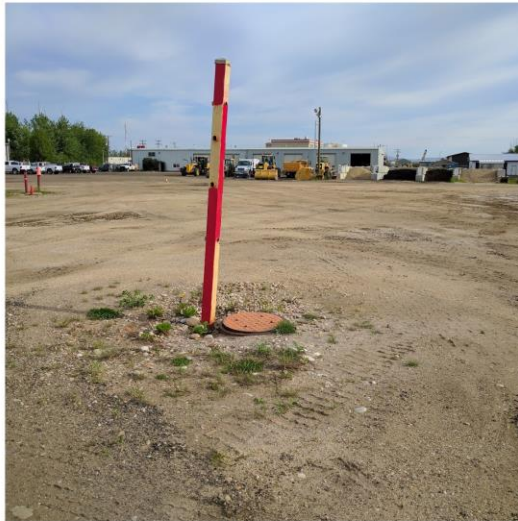
# Groundwater Recovery and Disposal

- Groundwater recovery system (GWRS) installed at a large diameter (150 mm dia.) recovery well (RW1) with a submersible pump.
- A pilot test conducted in 2014.
- RW1 and RW2 and associated infiltration trenches installed in 2015.

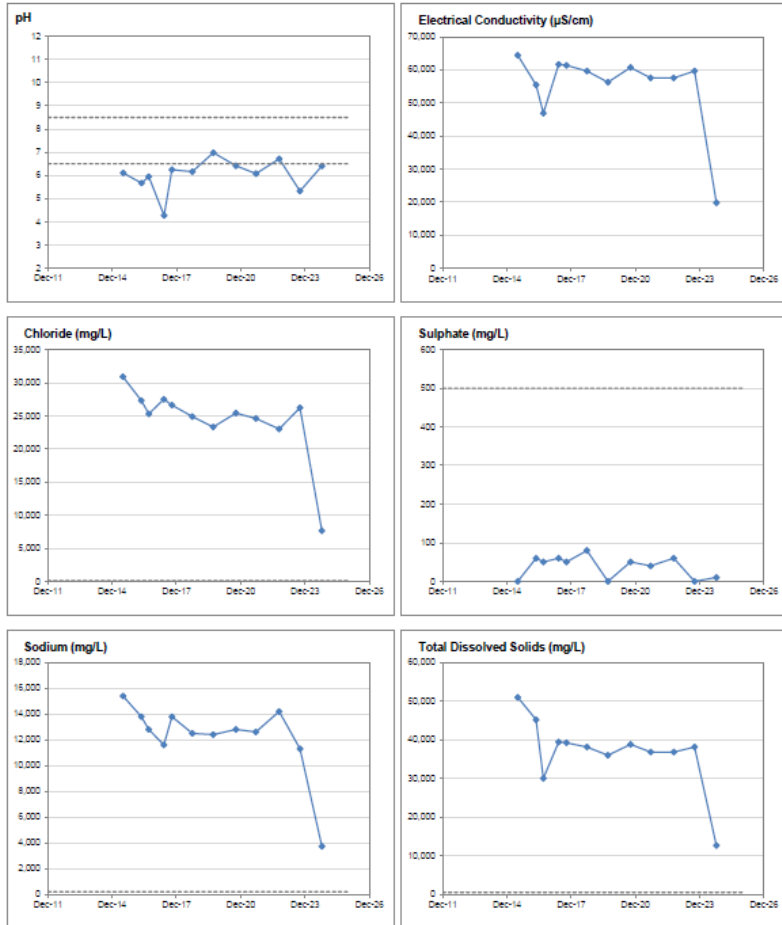
GROUNDWATER TREND CHARTS - MONITORING WELL TH15-7  
2024 SOIL AND GROUNDWATER ASSESSMENT ACTIVITIES  
TOWN OF SLAVE LAKE - PUBLIC WORKS YARD  
1009 - 7 STREET NE, SLAVE LAKE, AB

- Annual and semi-annual GWMPs.
- Decreasing chloride trends and retracting salinity plume.
- EM surveys completed at the site in 2012, 2018, and 2022.
- Results of the 2021 SST Evaluation
  - Limited reduction in the remedial excavation requirements.
  - Confirmed that the current RMP was protective of the nearest receptors.
